**PHASE I
ENVIRONMENTAL SITE ASSESSMENT**

17 Central Street
Ashburnham, Massachusetts

TRC Project Number: 38825-0020

Montachusett Regional Planning Commission

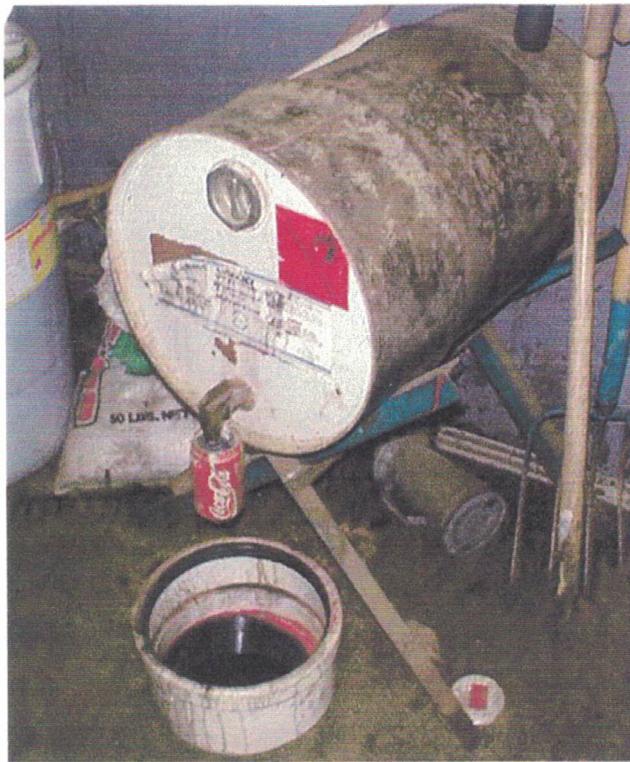
The four-vehicle garage, located adjacent to and to the east of the office is used for vehicle maintenance. Numerous hazardous substances and petroleum products used in connection with vehicle maintenance are stored in the garage. TRC observed 55-gallon drums containing motor oil, heavy-duty motor oil, hydraulic oil, windshield washer fluid, anti-freeze, detergents, and degreasing solvents. TRC also observed 55-gallon drums containing anti-freeze and propylene glycol in the five-vehicle garage located adjacent to the Water Department. All drums were labeled and in good condition with the exception of one drum. The drum was properly labeled as a gasoline additive and appeared to be in good condition, however there was evidence of spillage and presence of absorbent material beneath the drum. Refer to Photograph 1.

1) Drum of gasoline additive located in vehicle maintenance garage

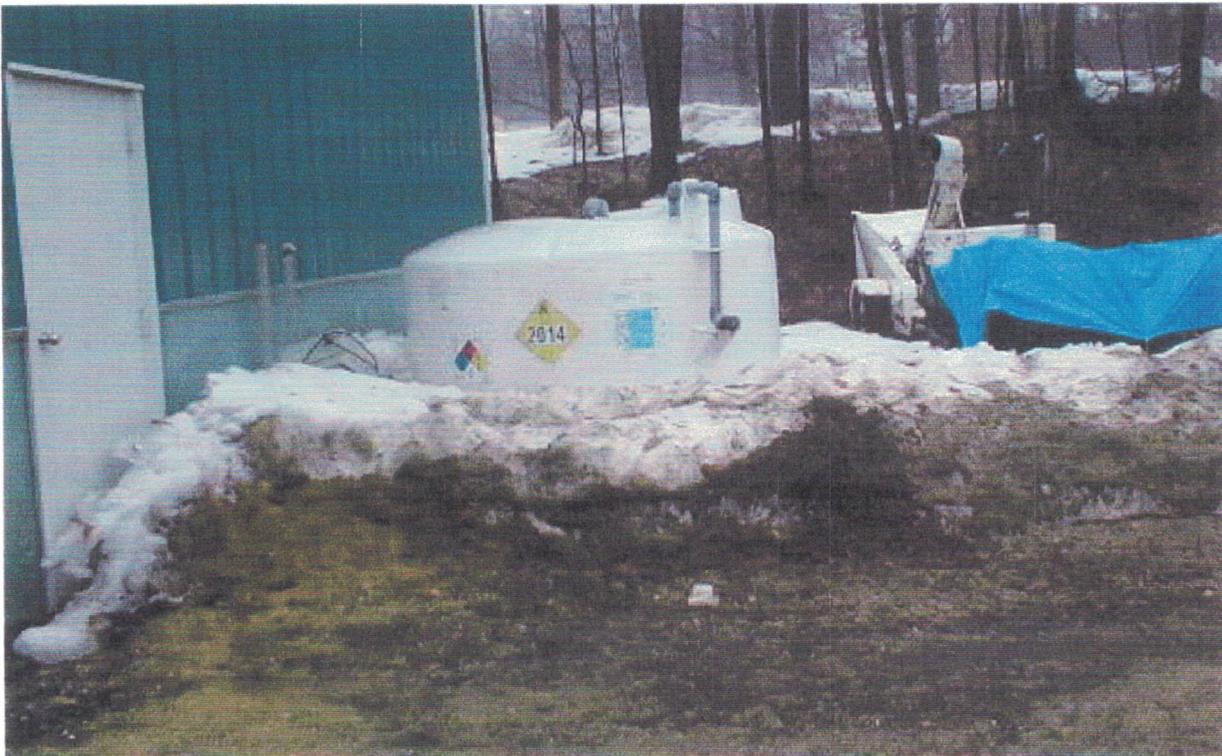
2) Empty liquid calcium container located adjacent to two-vehicle garage.

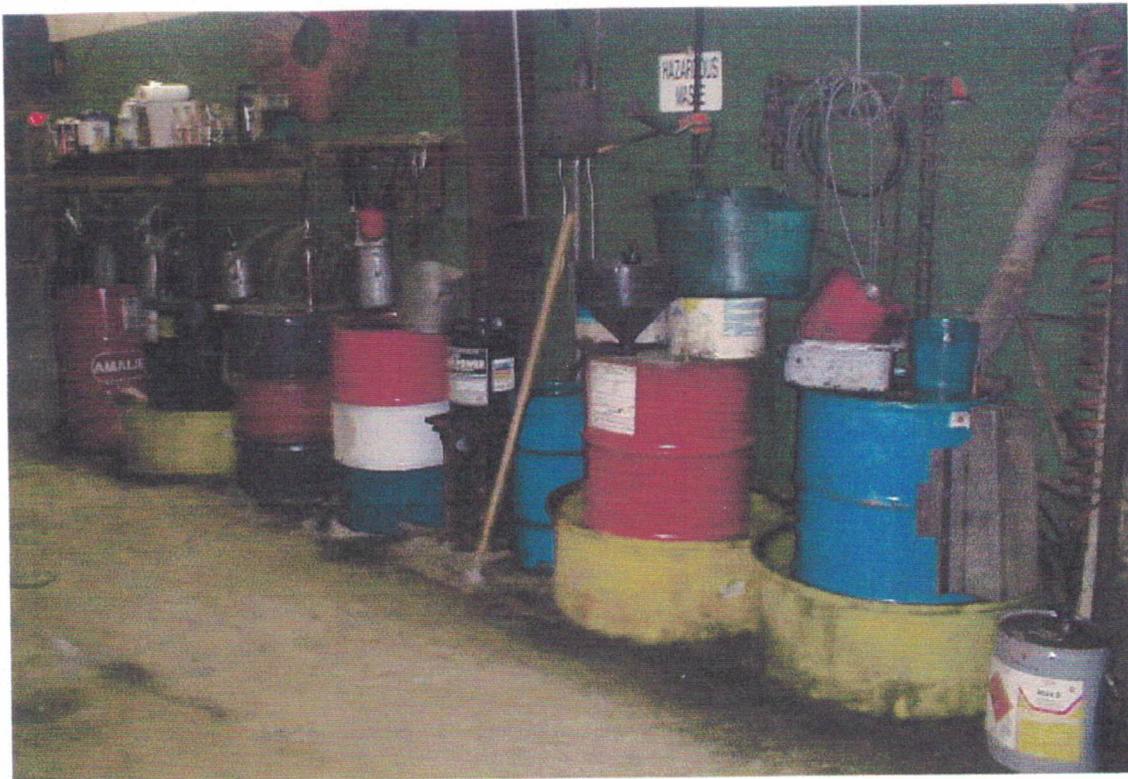
The four-vehicle garage, adjacent to the office is used for vehicle maintenance. Numerous hazardous substances and petroleum products used in connection with vehicle maintenance are stored in the garage. TRC observed 55-gallon drums containing motor oil, heavy-duty motor oil, hydraulic oil, windshield washer fluid, anti-freeze, detergents, and degreasing solvents. TRC also observed 55-gallon drums containing anti-freeze and propylene glycol in the five-vehicle garage located adjacent to the Water Department. All drums were labeled and in good condition with the exception of one drum. The drum was properly labeled as a gasoline additive and appeared to be in good condition, however there was evidence of spillage and presence of absorbent material beneath the drum. Refer to Photographs 1 and 3.

TRC observed a small area of stained pavement in the drum storage area in the vehicle maintenance garage, however there were no cracks or holes observed in the concrete floor of the garage. Due to the presence of snow and sand on the surface of the site, TRC was unable to completely observe site soils. Refer to Photograph 3.

3) Drums in vehicle maintenance garage containing motor oil, anti-freeze, heavy duty motor oil, hydraulic oil, windshield washer fluid, detergents and degreasing solvents.

On-Site Chemical Use and Storage – Several 55-gallon drums containing petroleum products, detergents, coolants, degreasers, and solvents were observed in the garages located on the site. All drums observed on the site were labeled and in good condition with the exception of one drum located in the vehicle maintenance garage adjacent to the office building. The drum was properly labeled as a gasoline additive and appeared to be in good condition, however there was evidence of spillage and presence of absorbent material beneath the drum. In general, staining on the garage floor was observed, but no apparent cracks or holes were observed. On-site chemical use and storage does is not considered a REC. Potential spillage of these materials is addressed above.

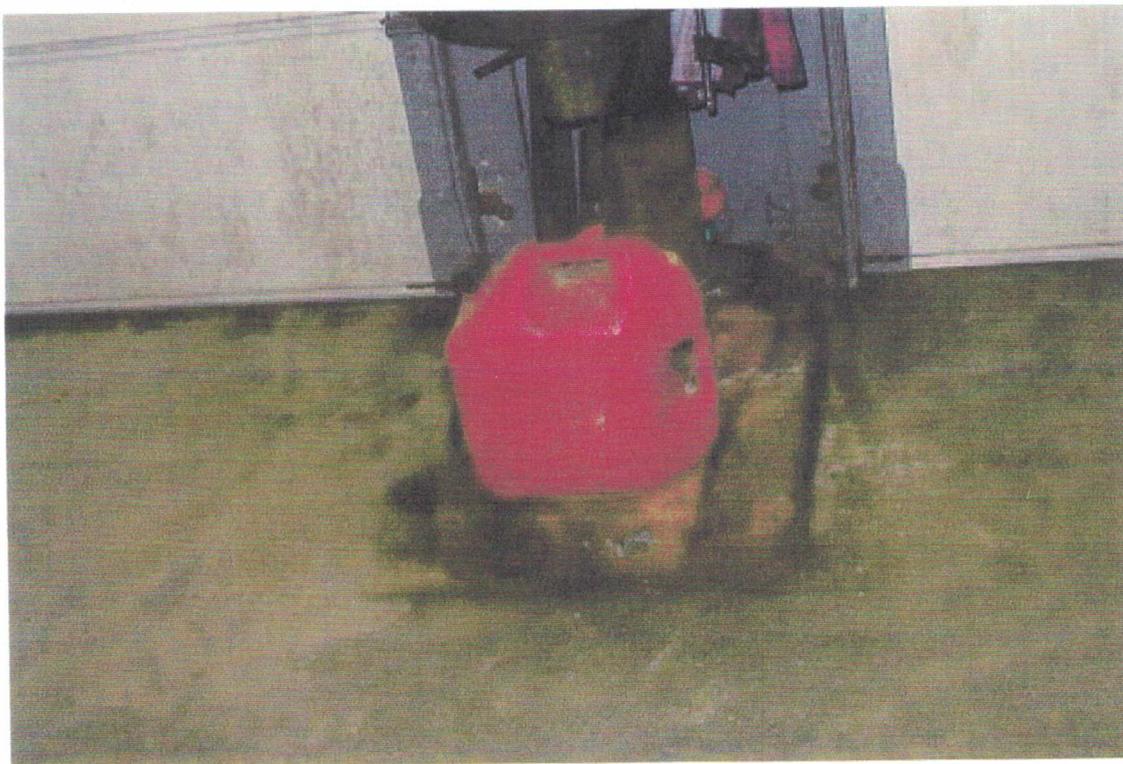
During the site reconnaissance TRC observed a red, two-gallon container, resting on a drill base. The site superintendent informed TRC that it was a container of diesel oil. Although the container appeared to be in good condition, the container was not labeled. Slight staining was observed on the floor around drill base. It was not apparent whether the staining was due to the presence of the container of diesel oil. Refer to Photograph 4.

4) Red two gallon container of diesel oil in vehicle maintenance garage – not labeled.

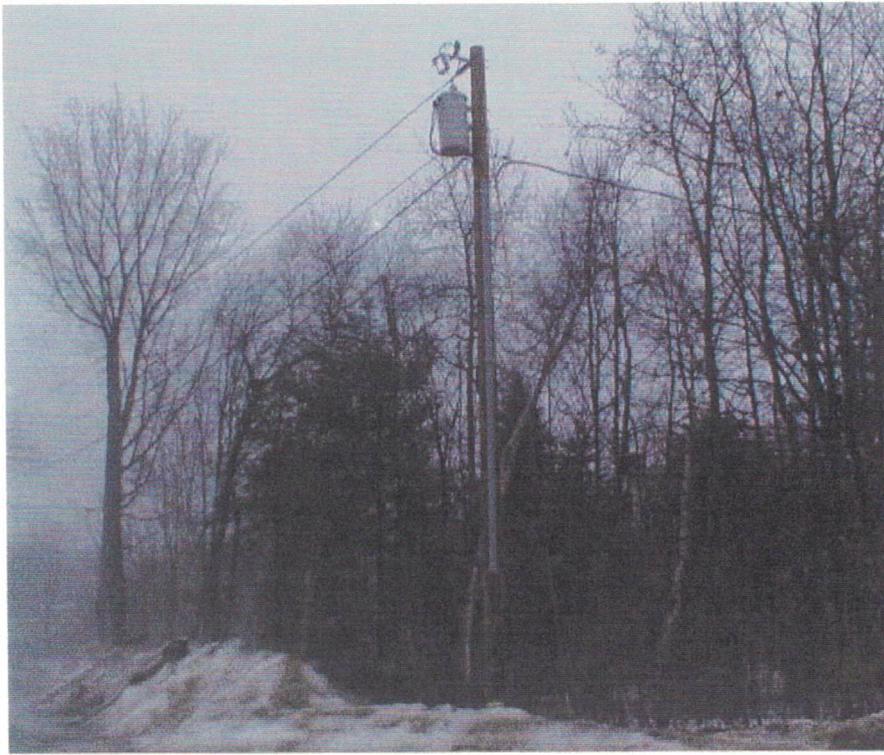
5) Pole mounted transformer located on east side of property near Maple Street entrance, looking southwest.

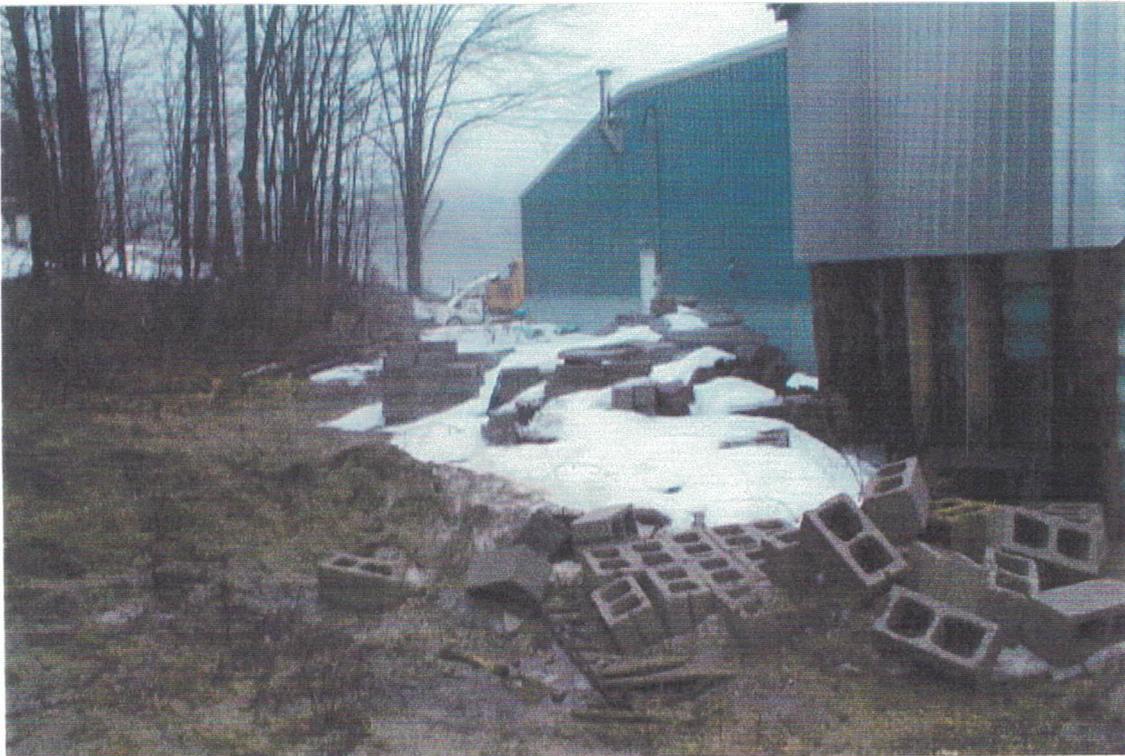
6) Cinder blocks located behind vehicle maintenance garage, looking east.

Solid Debris – Several debris piles consisting of scrap metal, cinder blocks, and an old truck body are located on site adjacent to the salt storage shed. These items do not indicate an existing release, or material threat of release of hazardous or petroleum products to the environment. Therefore, the presence of the solid waste piles is not considered a REC.

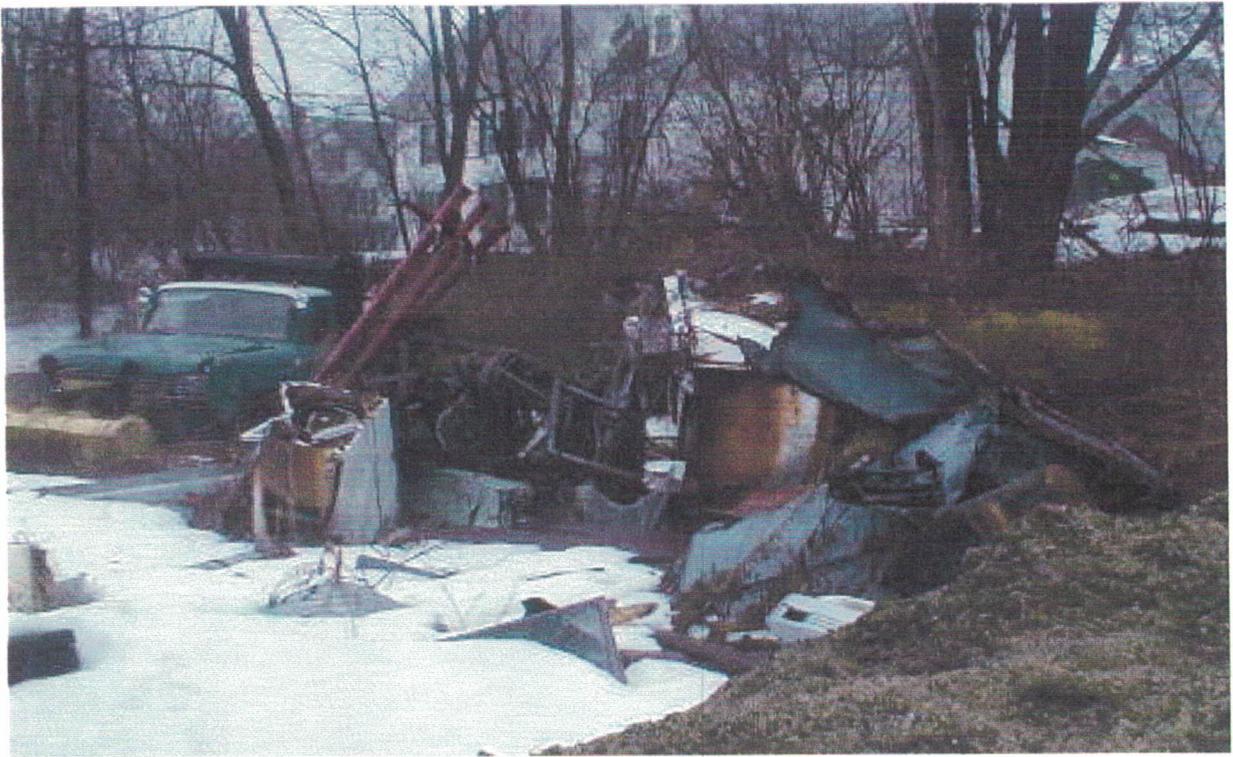
7) Scrap metal pile with old truck body, looking north.

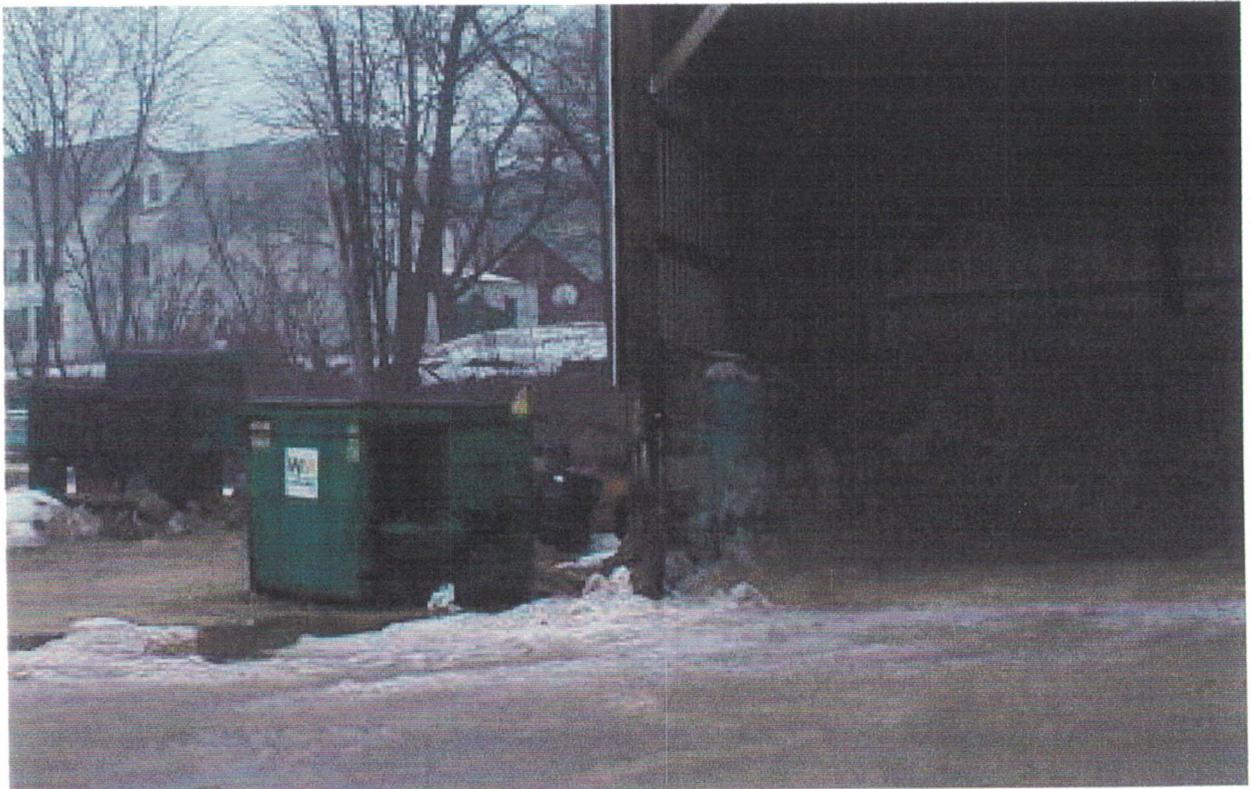
8) Dumpster adjacent to empty salt shed, looking north.

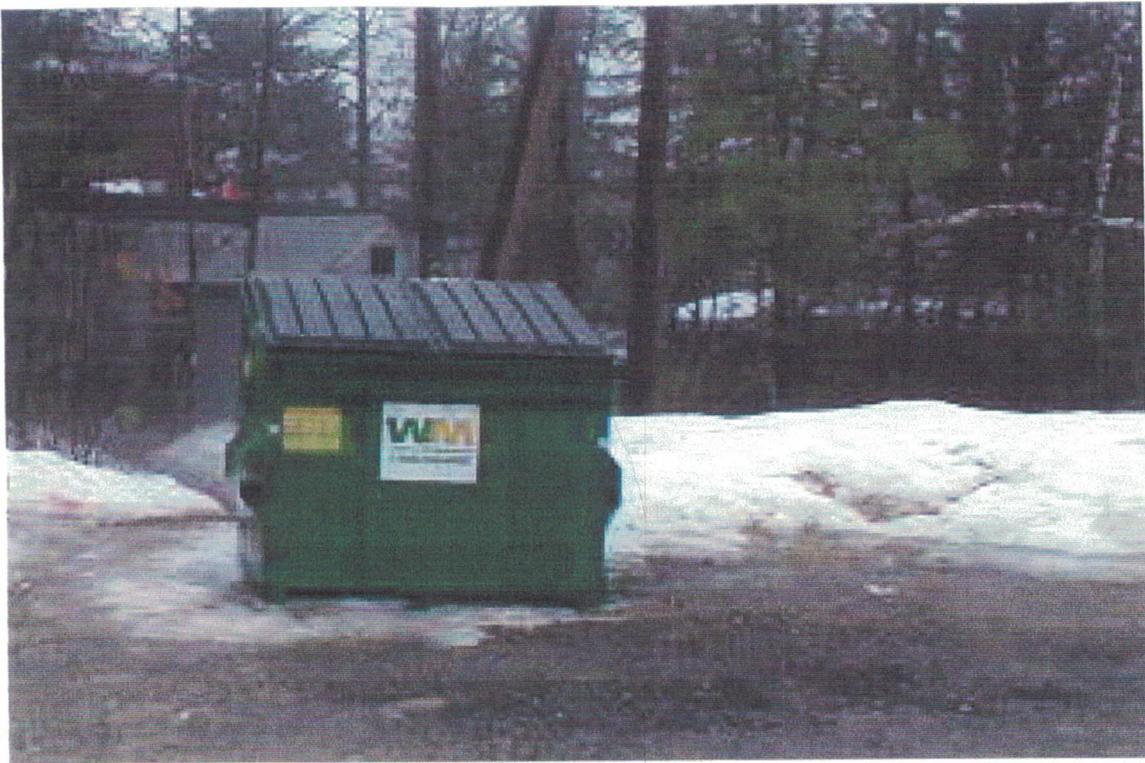
9) Dumpster along southern property boundary, looking south towards Puffer Street.

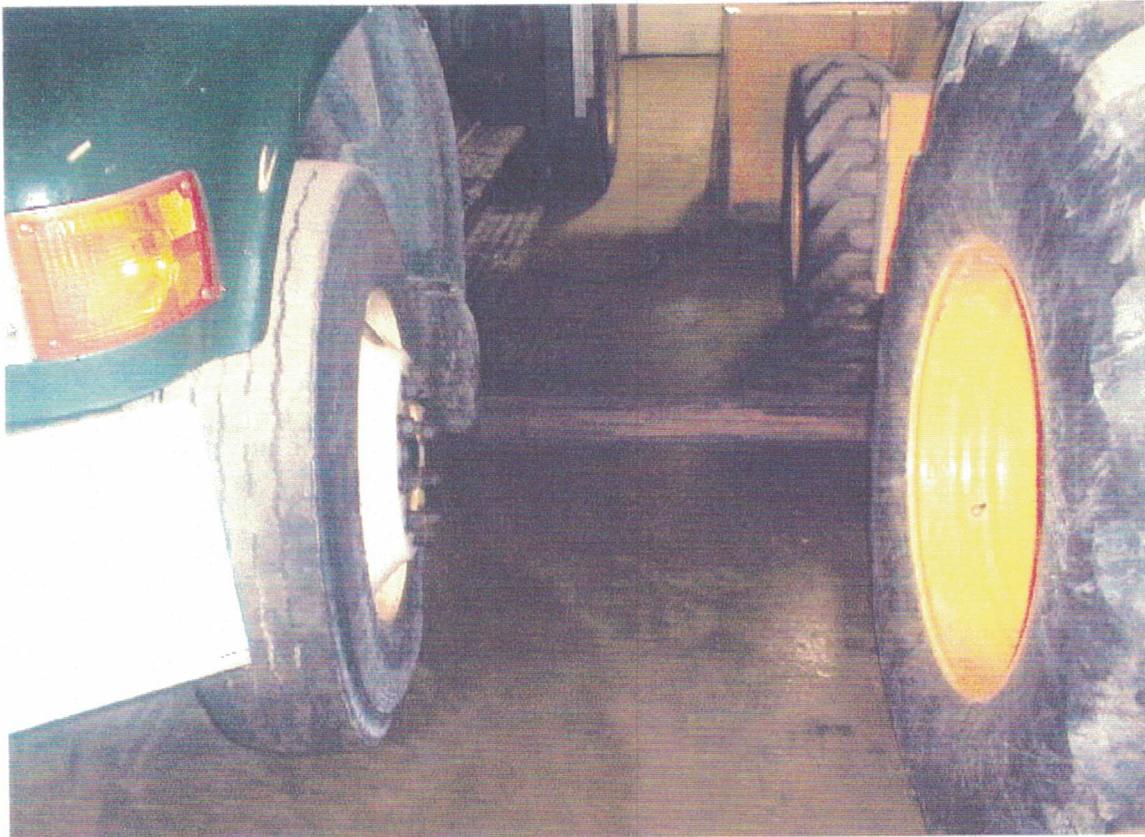
Direct Discharge of Trench Drain to Septic System – Prior to 1996, the trench drain in the vehicle maintenance garage reportedly discharged directly to the abandoned on-site septic system. Based on indications of past spills (i.e., floor staining) and the potential for petroleum and hazardous substances to have been discharged, the abandoned septic system is considered a current REC. The solvent, tetrachloroethene was detected in soil excavated during the UST removal and in groundwater from an on-site monitoring well sampled in October 1994.

Direct Discharge of Trench Drain to On-Site Storm Drain System – In 1996, discharge of the trench drain in the vehicle service garage was changed from the septic system to the on-site storm drain system. Based on the potential for petroleum and hazardous substances to have been discharged or to be discharged in the future, the current configuration of the trench drain system is considered a current REC.

10) Trench drain located in vehicle maintenance garage.
